Roxhill (Junction 15) Limited  
Northampton Gateway  
Northamptonshire

WATER FRAMEWORK DIRECTIVE  
COMPLIANCE ASSESSMENT

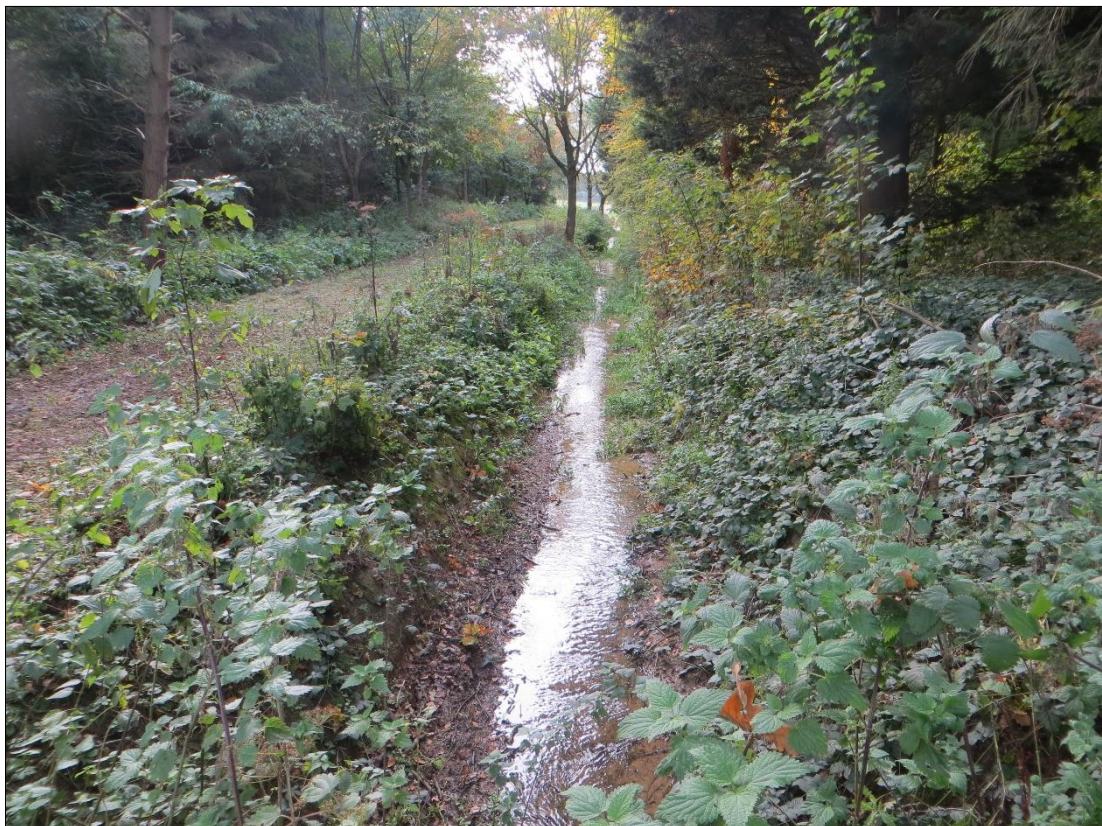
**Figure 5.1 – Courteenhall Brook - Tributary of the Wootton Brook (south of the site)**

- 5.3 As the Courteenhall Brook flows from west to the east adjacent to the south of the site, it follows a very narrow and uniform channel (maximum 1m wide) with shallow banks. Water depth at the time of the site visit was very shallow (approximately 5cm max). It was evident that the ditch runs dry at times, as terrestrial ruderal herbs were present across the channel in some places (**Figure 5.1**). The bed substrate mainly consisted of fine mud and gravels. The depth and cover of silt increased further downstream towards the M1 (**Figure 5.2 & 5.3**).

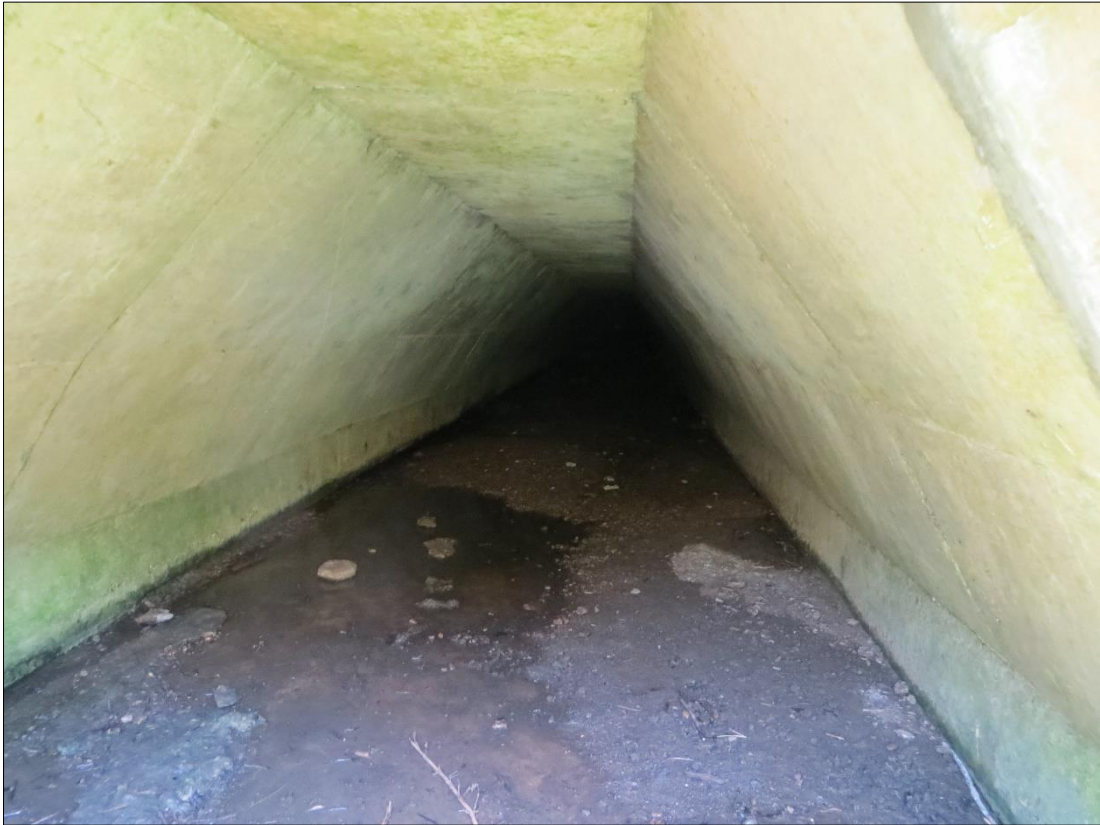
**Figure 5.4 – Culvert under A508 Roundabout**

- 5.4 A trapezoidal culvert is present under the A508 roundabout. On the day of the survey flow was minimal through the culvert and mud/silt blocked the passage of water (**Figure 5.4**). Due to the minimal light penetration within the culvert, there were no macrophytes present.

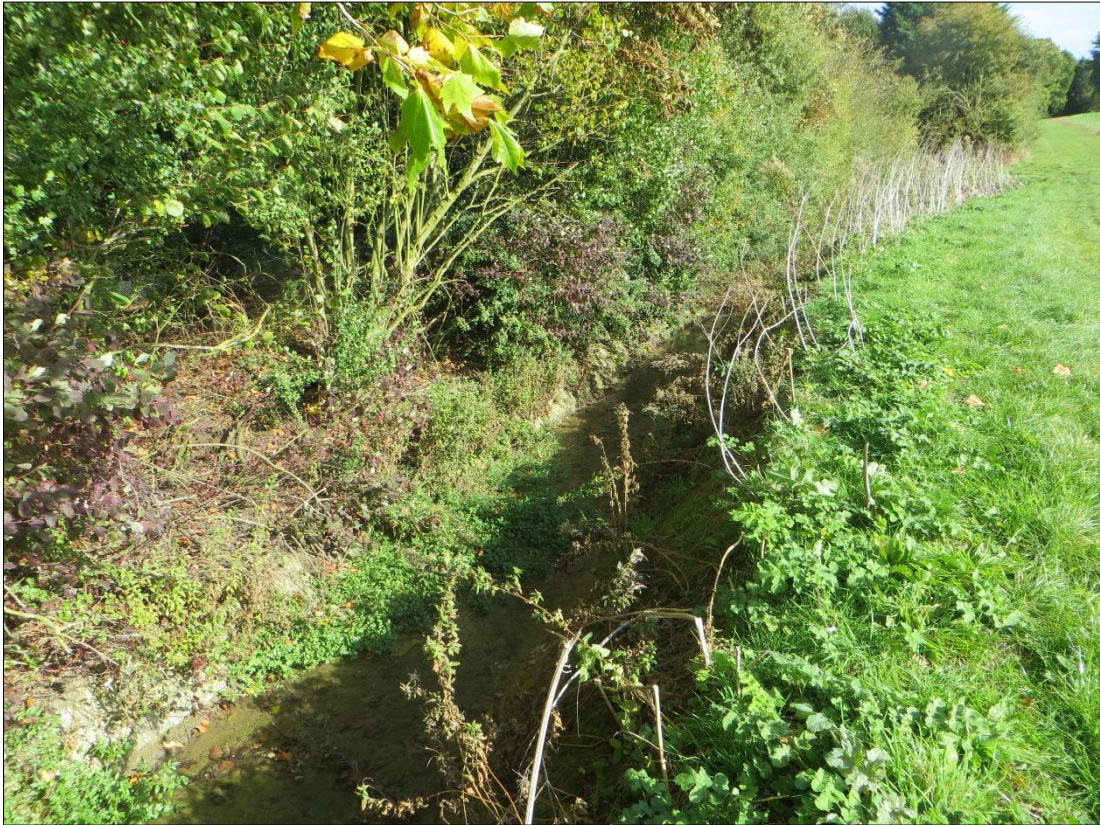
**Figure 5.5 – Courteenhall Brook**

- 5.5 Approximately 700m to the south of the site there is another unnamed tributary of the Wootton Brook that converges with the Courteenhall Brook as it goes under the M1. This watercourse essentially acts as a field ditch with a maximum width of 1m. Flow was minimal at the time of survey, emphasised by the mats of filamentous algae *Cladophora* sp..
- 5.6 The ditch had 100% macrophyte coverage at the time of the survey, which mainly comprised of filamentous algae with some beds of watercress *Rorippa nasturtium-aquaticum* (**Figure 5.5**).
- 5.7 The Courteenhall Brook is heavily shaded by a hedgerow on the left hand bank with open field on the right hand bank.
